ecology and environment. inc.

Date: April 22, 1994

Subj: Site Assessment: TRI Container
Catoosa, Rogers Co., Oklahoma
TDD#: T06-9311-011
PAN : EOK0419SA

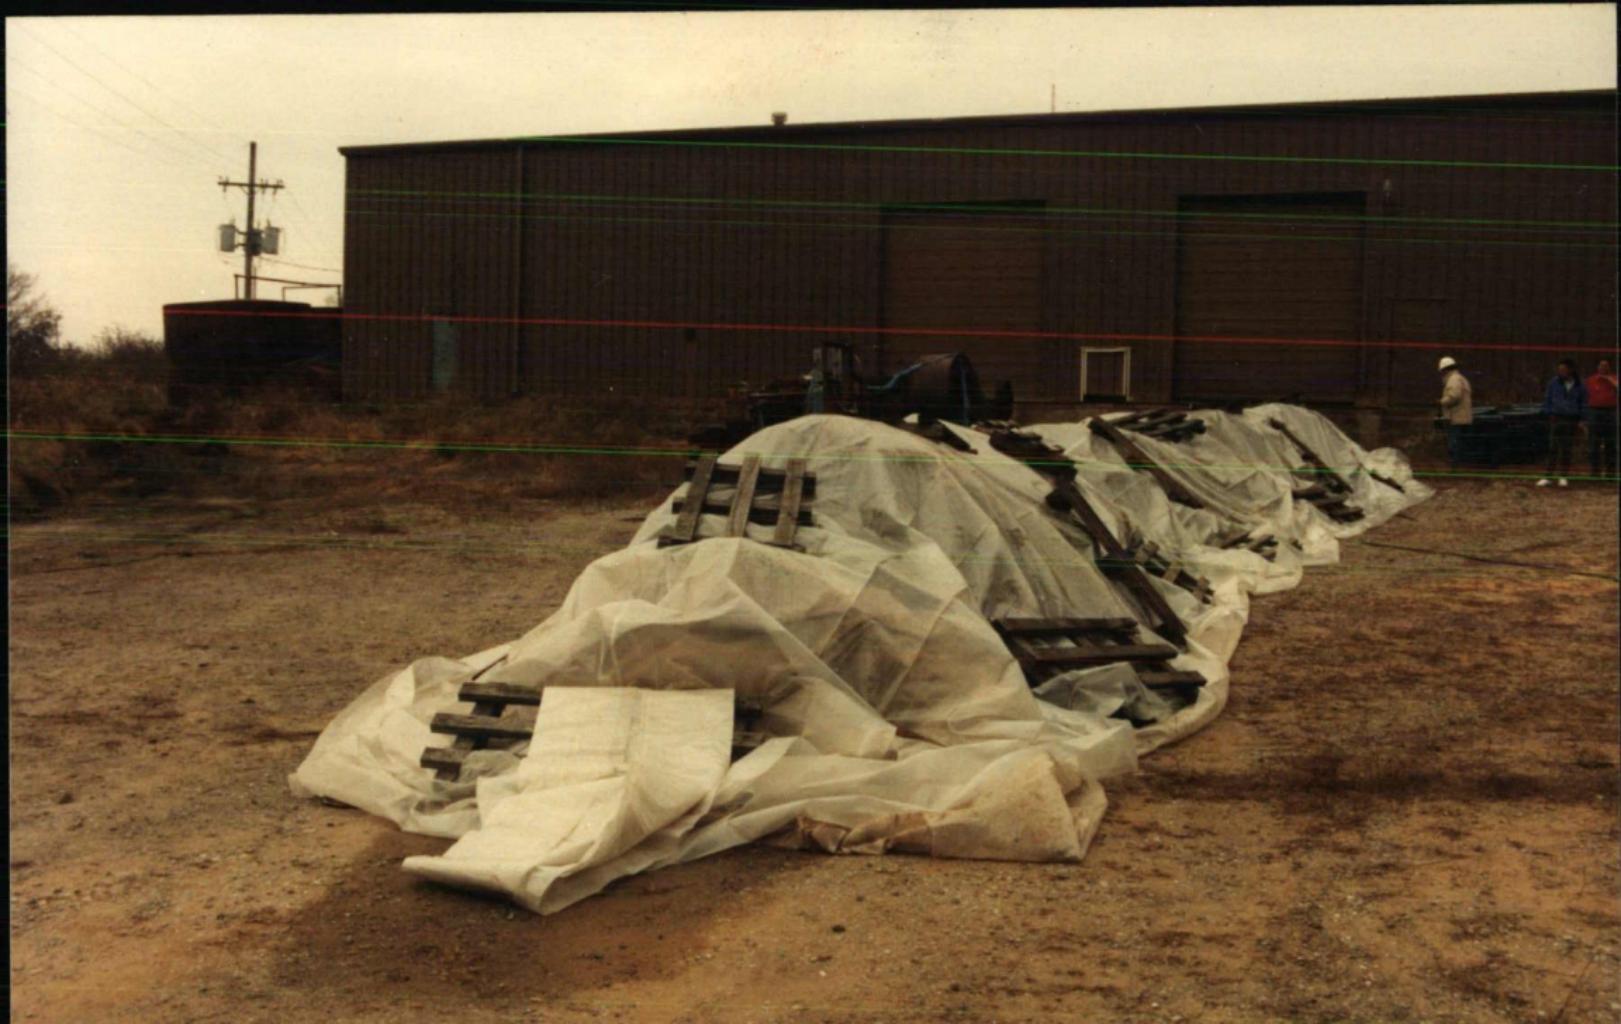
SITE NAME: TRI CONTAINER, INC. TOD# T06-9311-011
PHOTO #: 101 PHOTOGRAPHER/WITNESS: NEELEY/LONG/BANIPAL
DATE: 11/09/93 TIME: 1035 DIRECTION: SE
EXCAVATED SOIL STOCKPILE FROM SPILL AREA.

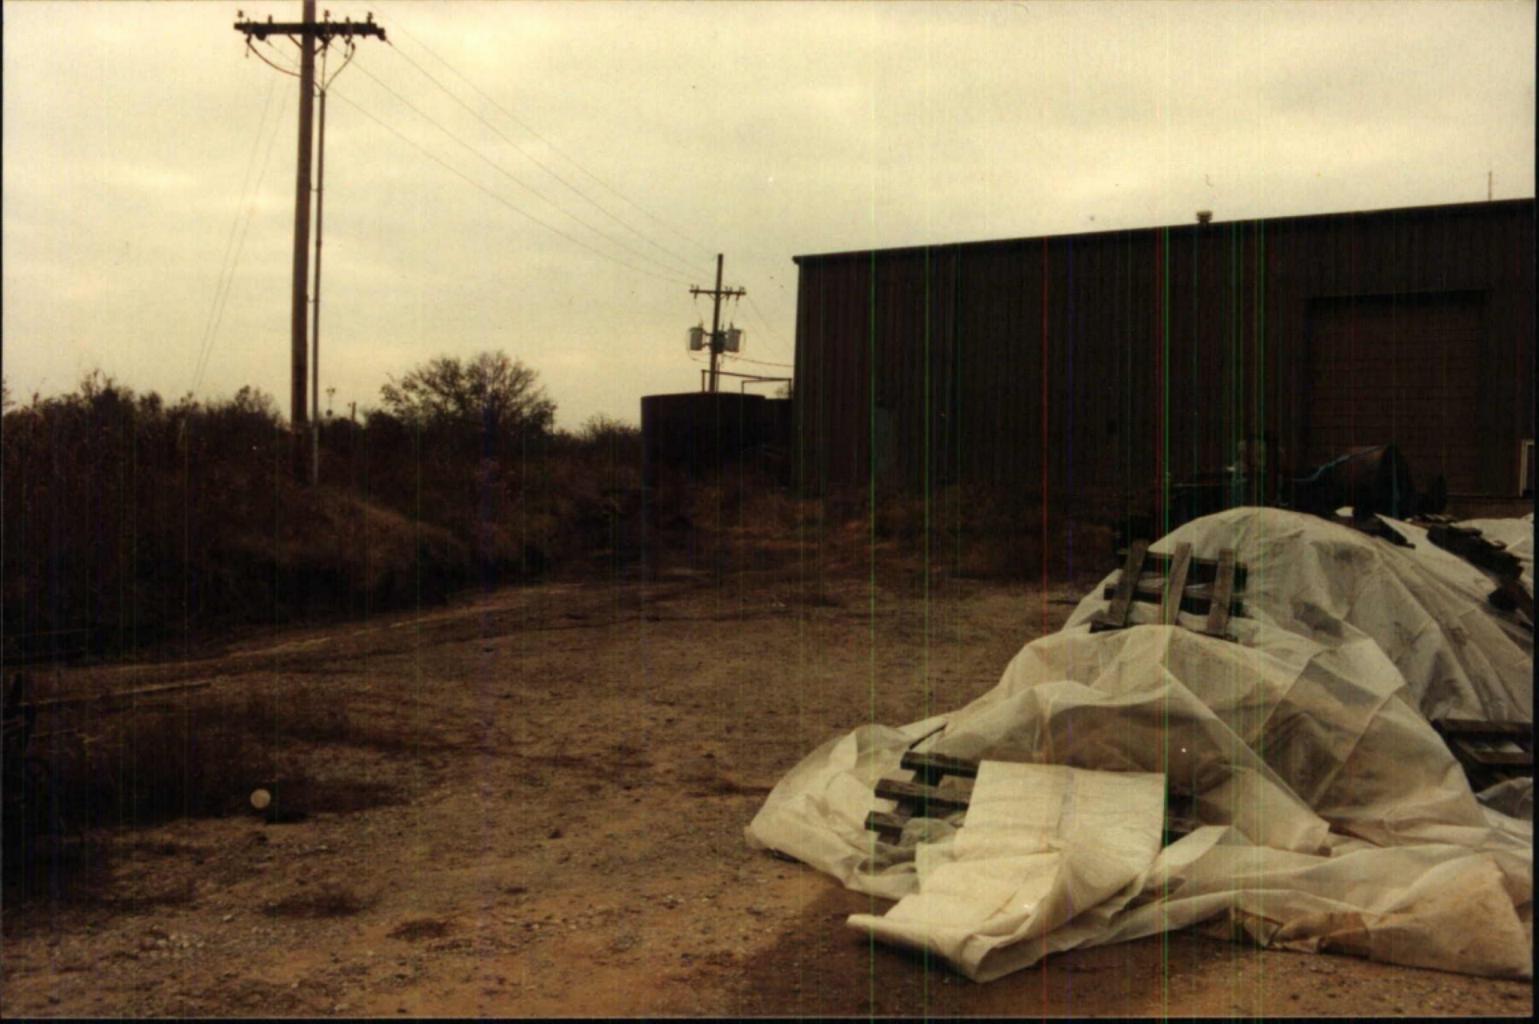
1-2

SITE NAME: TRI CONTAINER, INC. TDD# : T06-9311-011
PHOTO #: 102 PHOTOGRAPHER/WITNESS: NEELEY/LONG/BANIPAL
DATE: 11/09/93 TIME: 1035 DIRECTION: SE
SPILL AREA ILLUSTRATING SOIL STOCKPILE AND TANK T-1A.

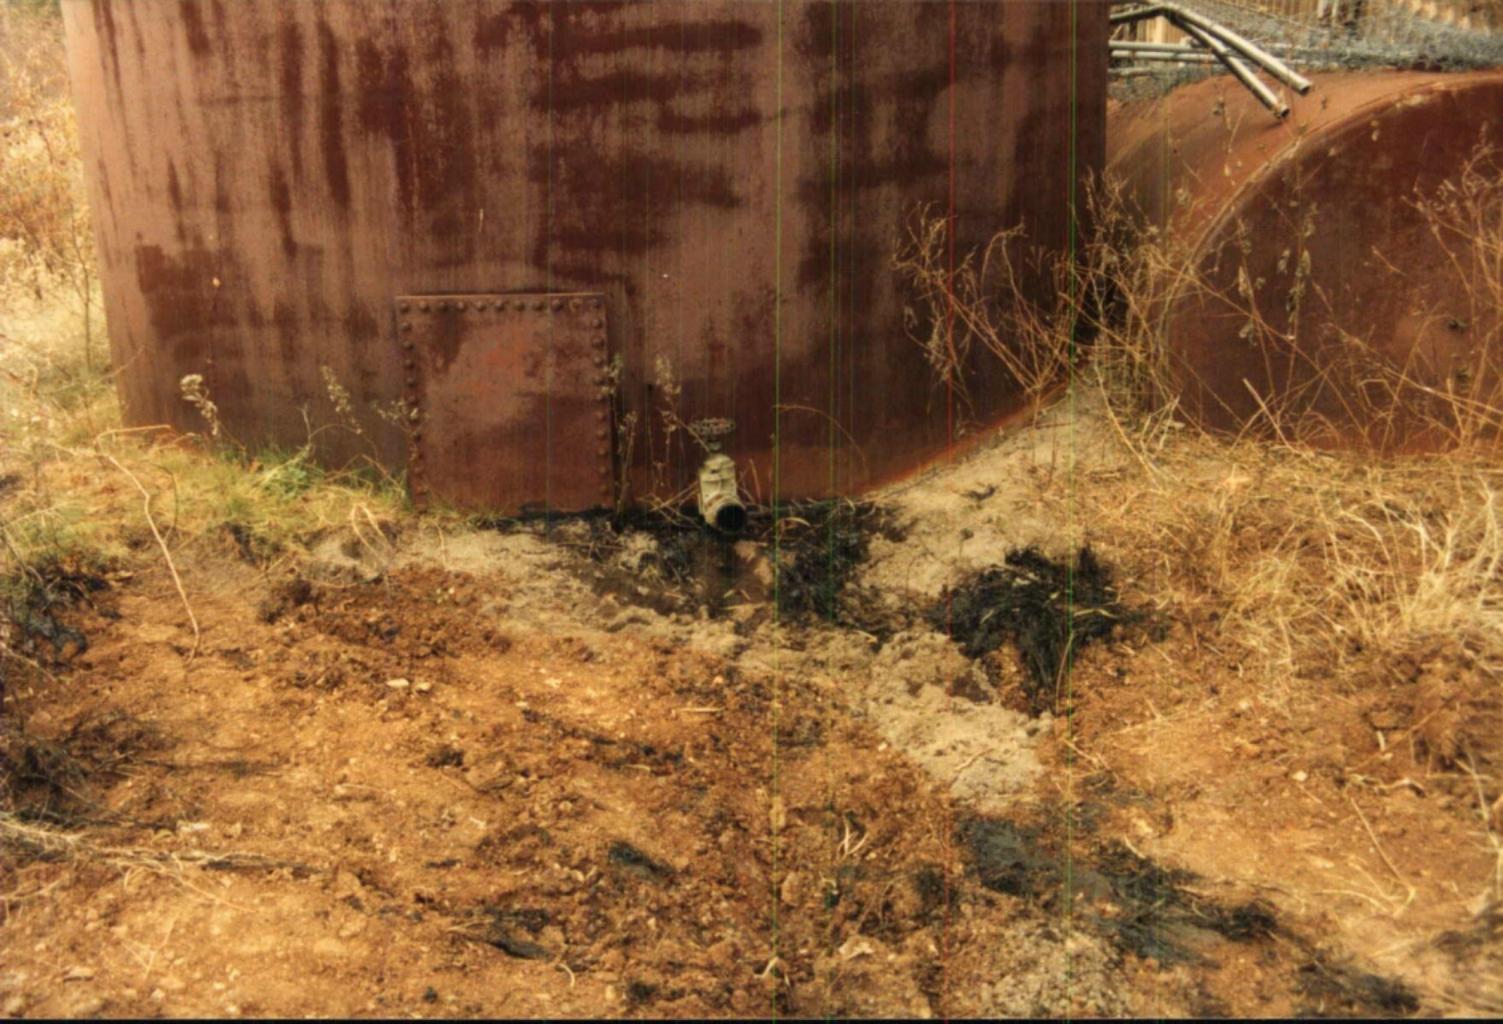
1-3

SITE NAME: TRI CONTAINER, INC. TDS: T06-9311-011
PHOTO #: 103 PHOTOGRAPHER/WITNESS: NEELEY/LONG/BANIPAL
DATE: 11/09/93 TIME: 1036 DIRECTION: S
TANK T-1A. SPILL OCCURRED FROM VALVE ON BOTTOM OF TANK. NOTE:
WASTE OIL RESIDUE ON GROUND.

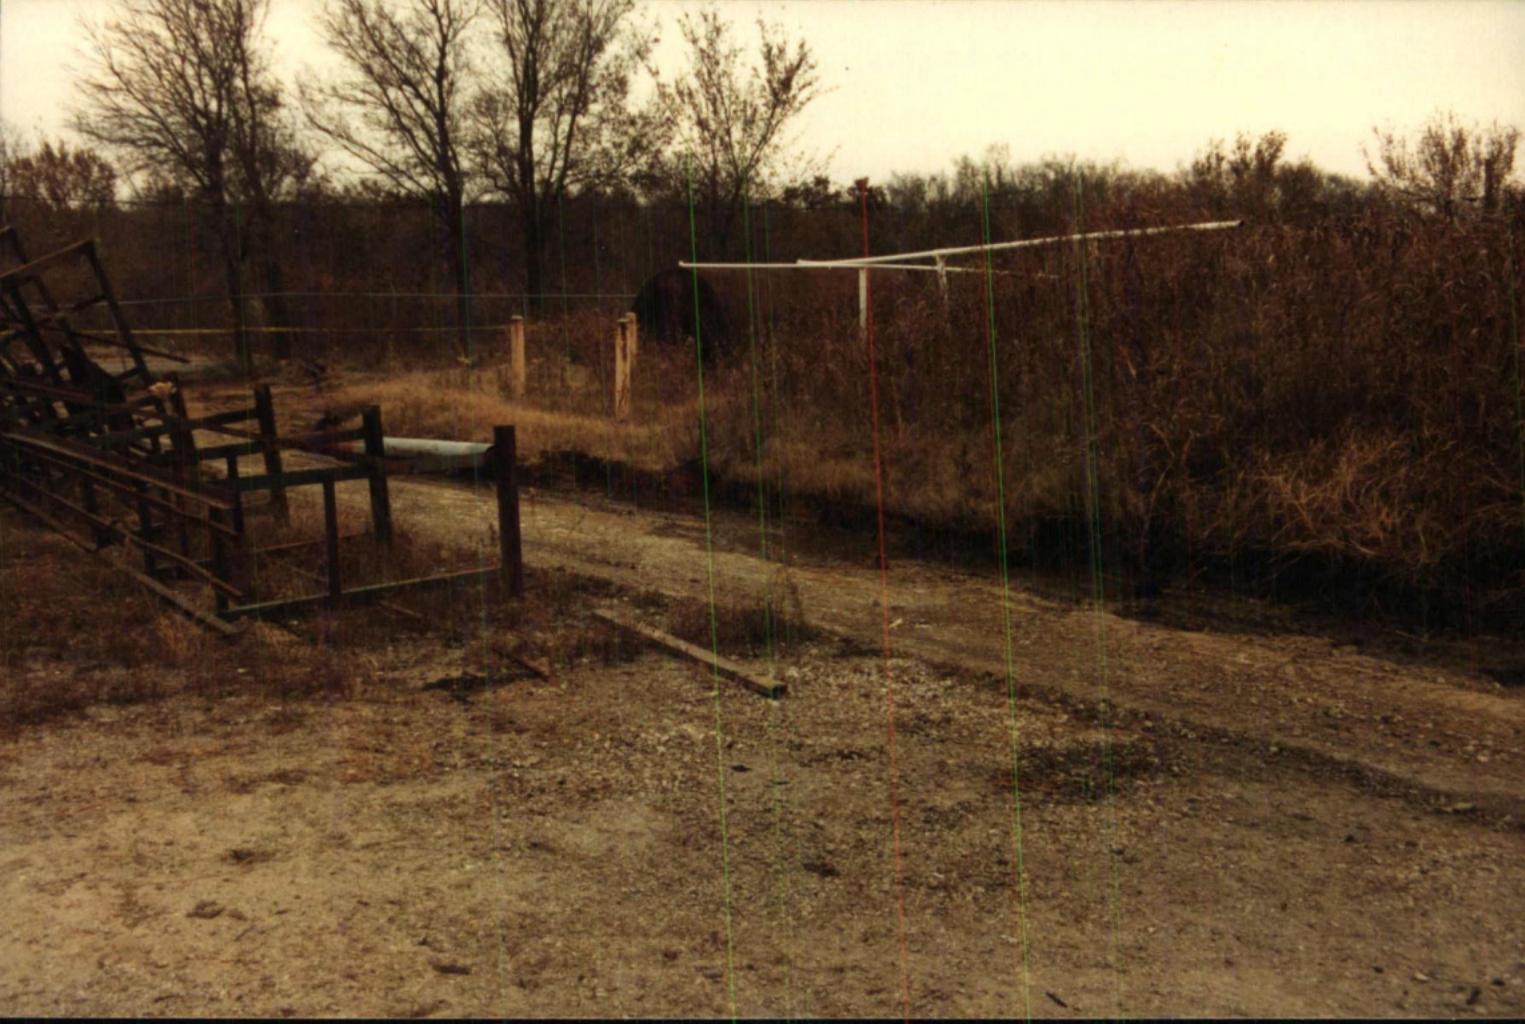
1-4

SITE NAME: TRI CONTAINER, INC. TOD# T06-9311-011
PHOTO# 104 PHOTOGRAPHER/WITNESS: NEELEY/LONG/BANIPAL
DATE: 11/09/93 TIME: 1037 DIRECTION: NE
PATH OF SPILL ALONG TRENCH TOWARD FENCE.

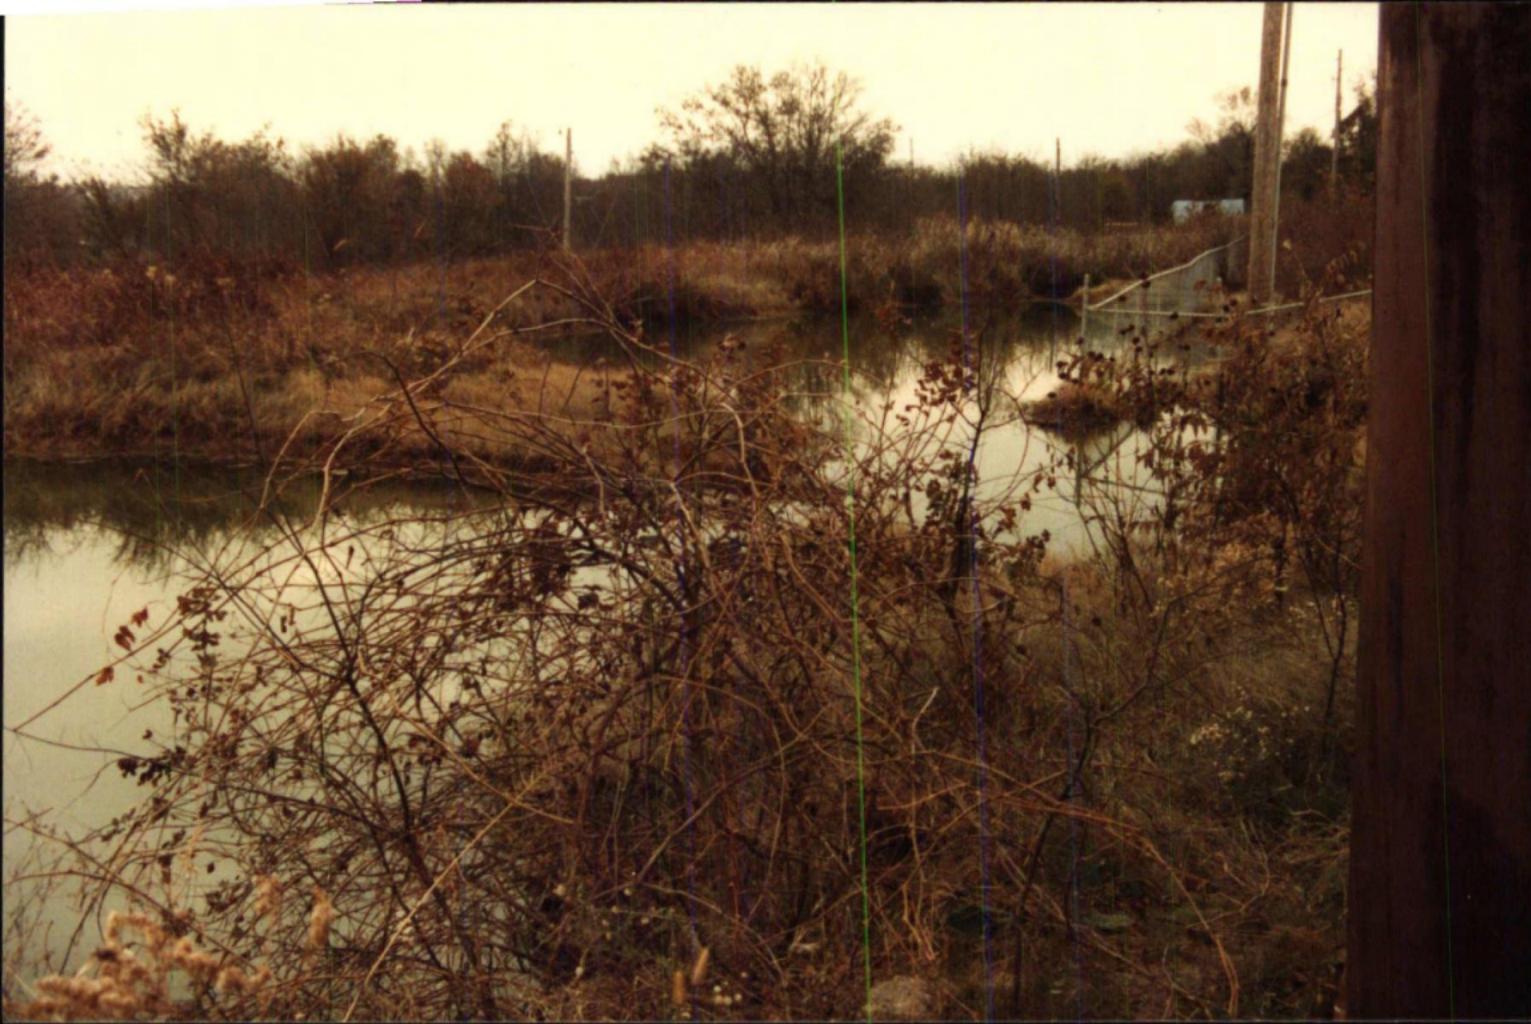
SITE NAME: TRI CONTAINER, INC. TOD #: T06-9311-011
PHOTO #: 106 PHOTOGRAPHER/WITNESS: NEELEY/LONG/BANIPAL
DATE: 11/09/93 TIME: 1038 DIRECTION: SE
WASTEWATER PONDS (LAGOONS)

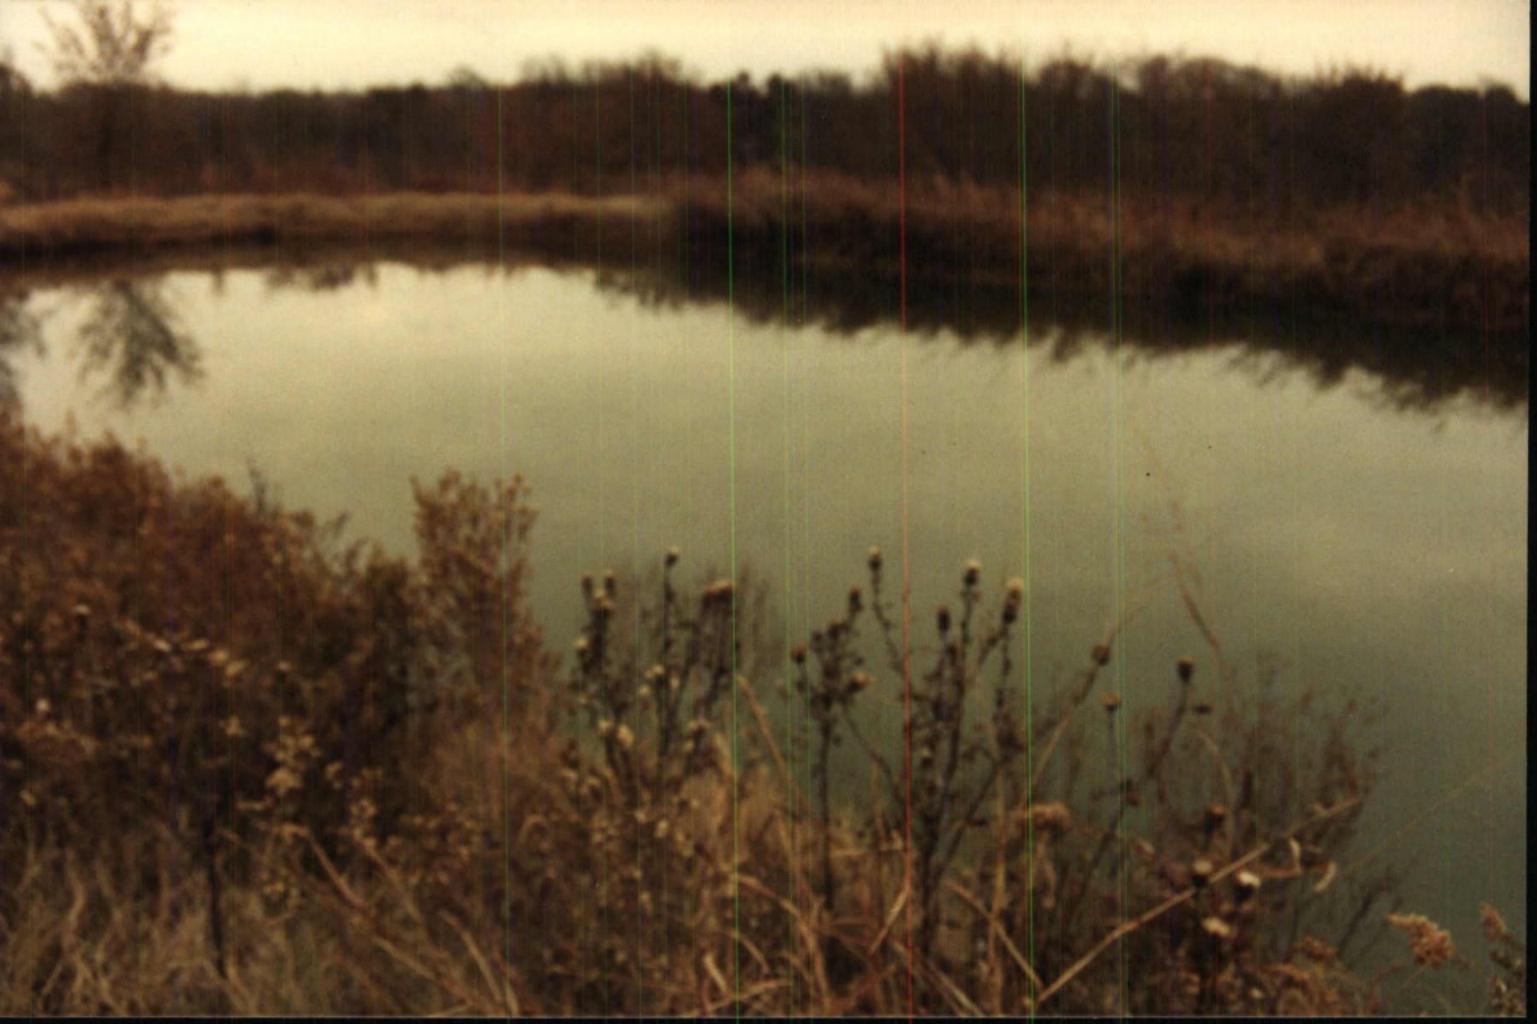
SITE NAME: TRI CONTAINER, INC. TOD#: T06-9311-011
PHOTO#: 107 PHOTOGRAPHER/WITNESS: NEELEY/LONG/BANIPAL
DATE: 11/09/93 TIME: 1038 DIRECTION: NE
WASTEWATER POND (LAGOON)

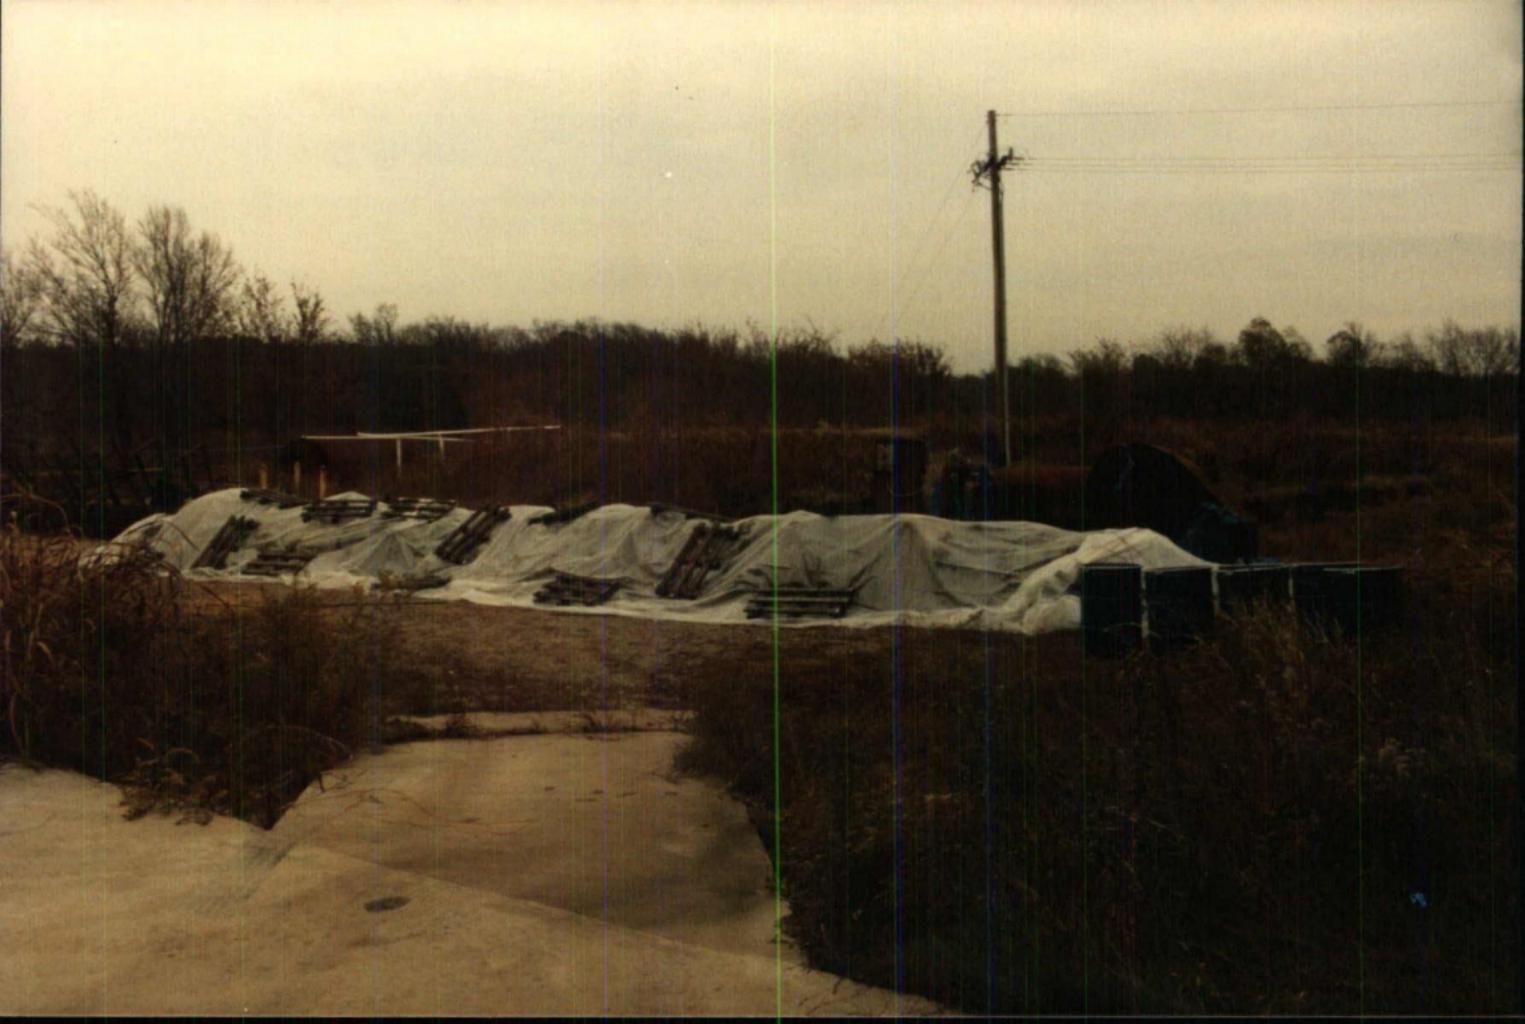
1-8

SITE NAME: TRI CONTAINER, INC. TDD#: T06-9311-011
PHOTO#: 108 PHOTOGRAPHER/WITNESS: NEELEY/LONG/BANIPAL
DATE: 11/09/93 TIME: 1039 DIRECTION: NE
EXCAVATED SOIL STOCKPILE.

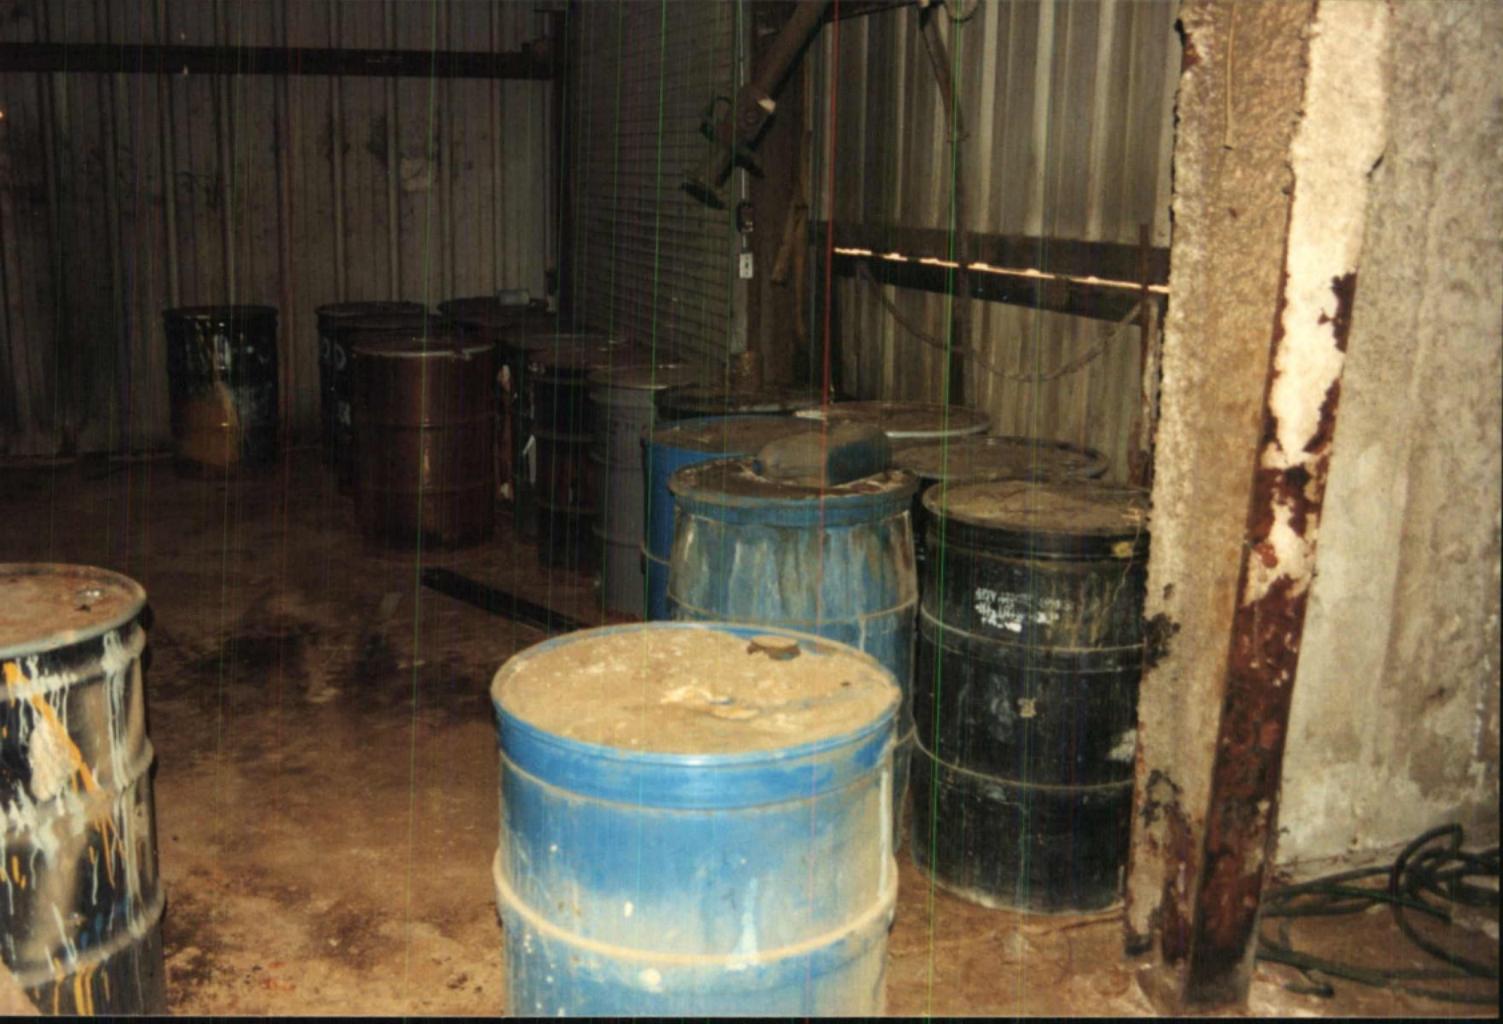
SITE NAME: TRI CONTAINER, INC. TDO# : T06-9311-011
PHOTO# : 110 PHOTOGRAPHER\WITNESS: NEELEY/LONG/BANIPAL
DATE: 11/09/93 TIME: 1045 DIRECTION:
WAREHOUSE INTERIOR, SOUTHBAY. DRUMS CONTAINING PAINT WASTE,
CORROSIVES AND CAUSTICS.

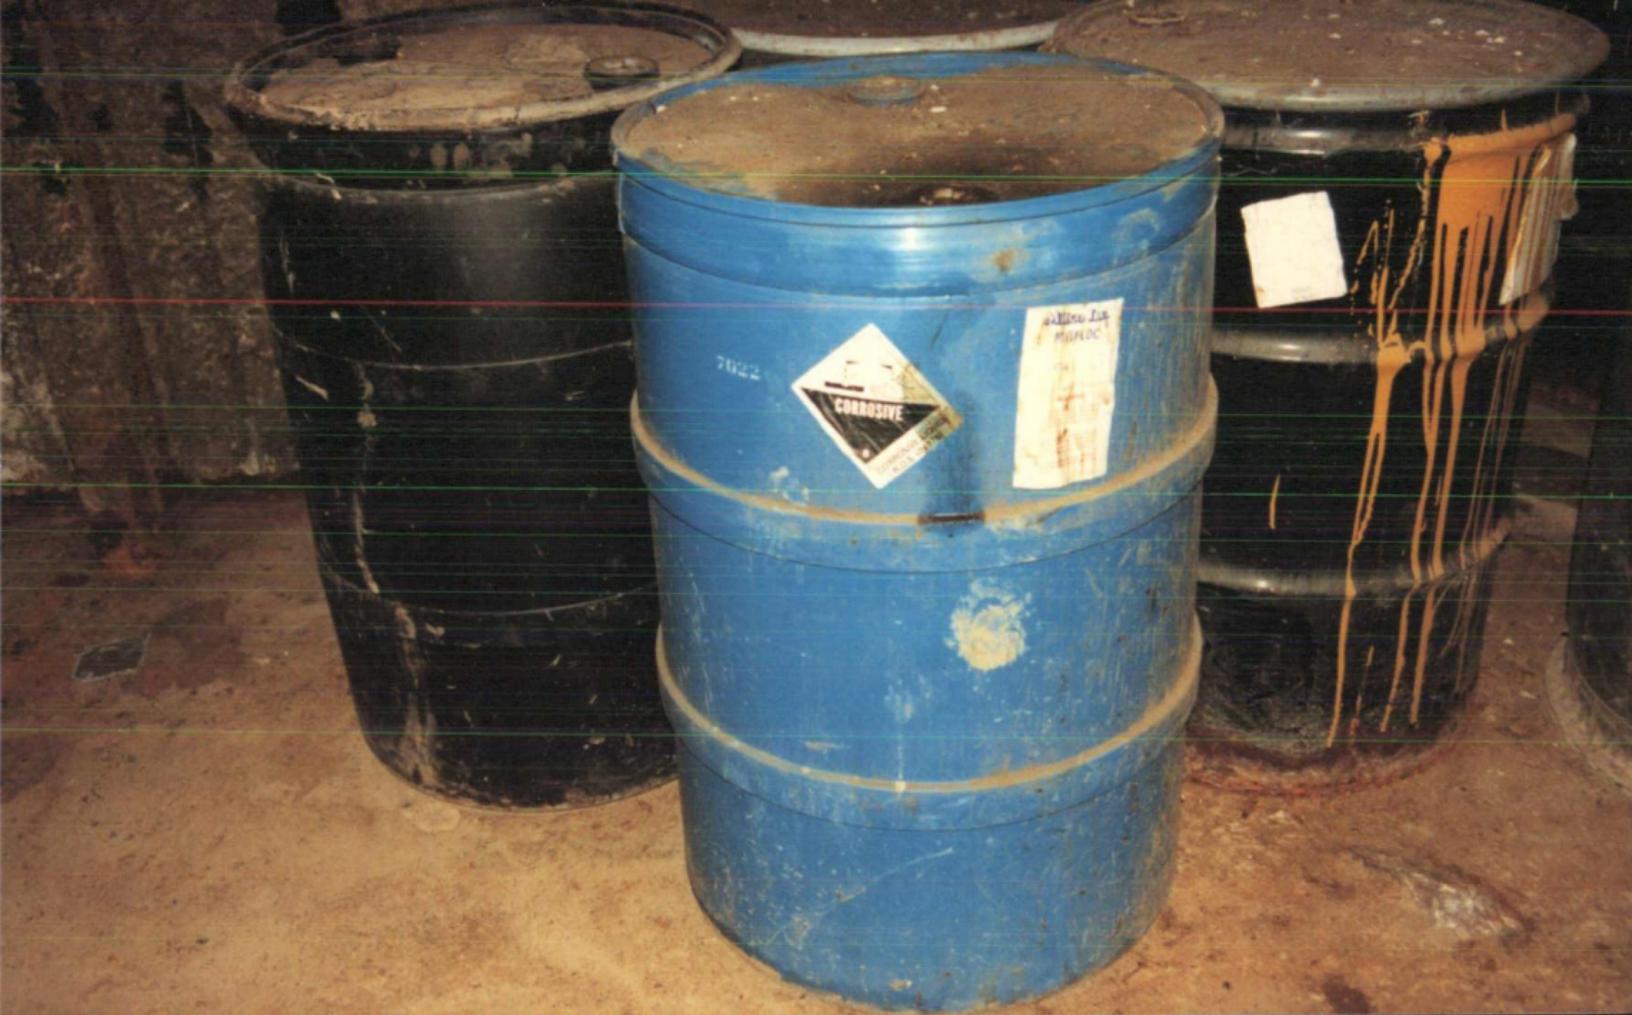
1-11

SITE NAME: TRI CONTAINER, INC. TDS: T06-9311-011
PHOTO: 111 PHOTOGRAPHER: WITNESS: NEELEY/LONG/BANIPAL
DATE: 11/09/93 TIME: 1045 DIRECTION:
WAREHOUSE INTERIOR, SOUTHBAY. DRUM LABELED CORROSIVE.

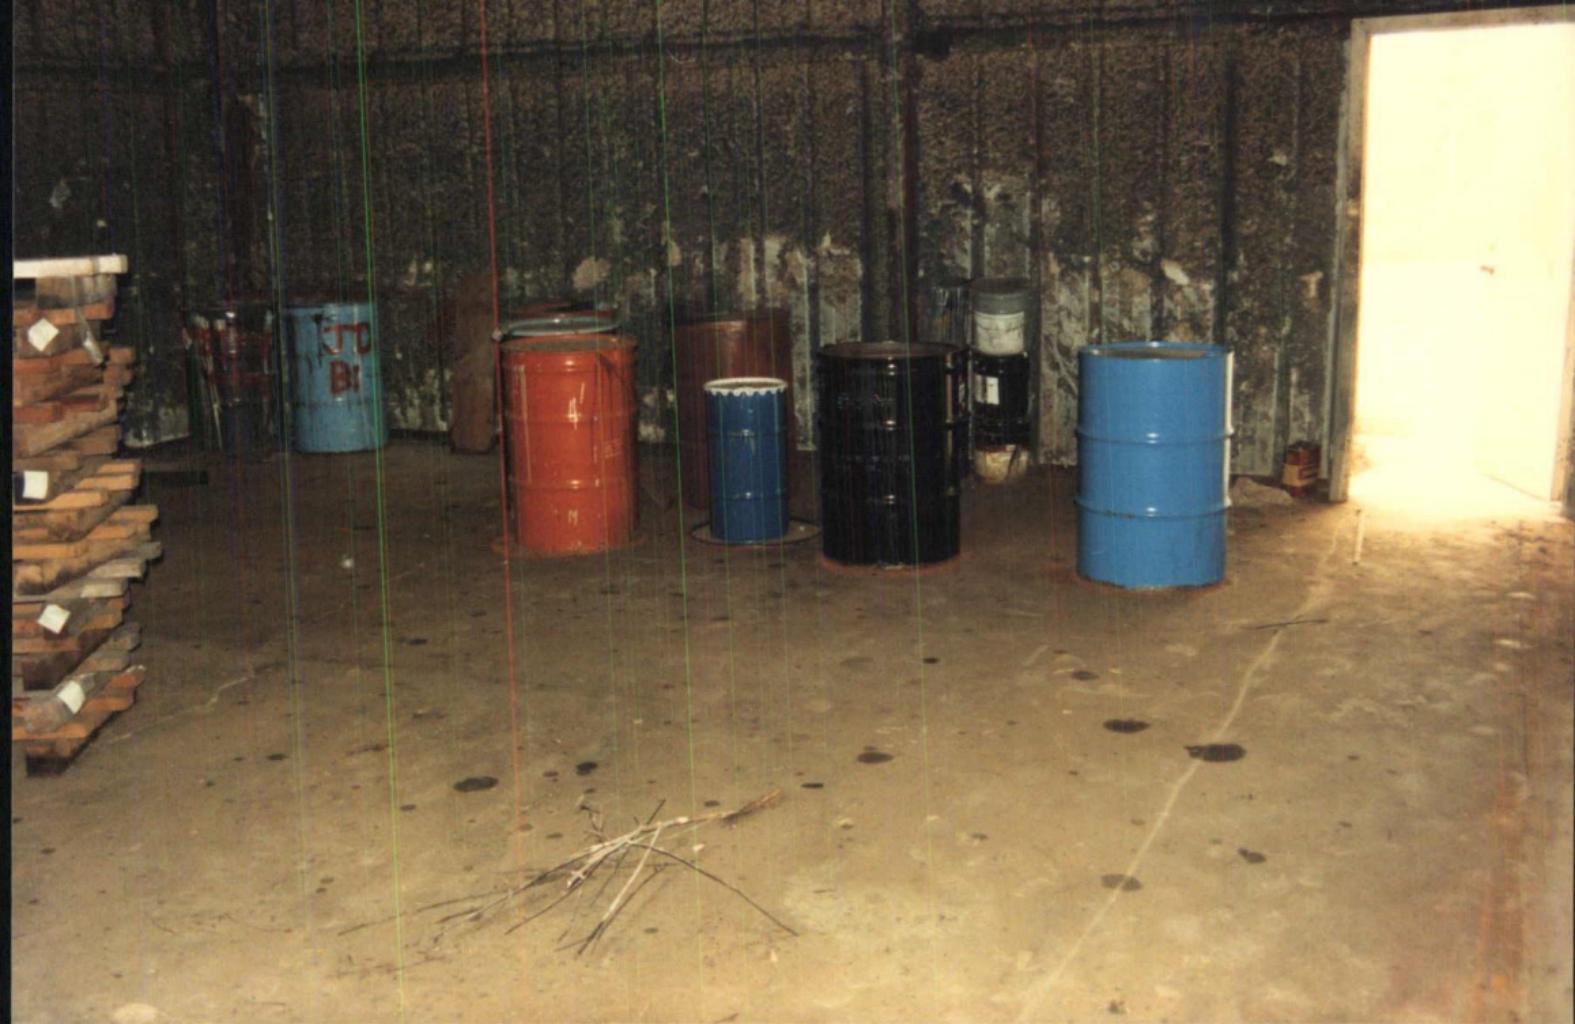
1-12

SITE NAME: TRI CONTAINER, INC. TDD#: T06-9311-011
PHOTO#: L12 PHOTOGRAPHER/WITNESS: NEELEY/LONG/BANIPAL
DATE: 11/09/93 TIME: 1045 DIRECTION: W
WAREHOUSE INTERIOR, SOUTHBAY. VARIOUS DRUMS CONTAINING PAINT
WASTE.

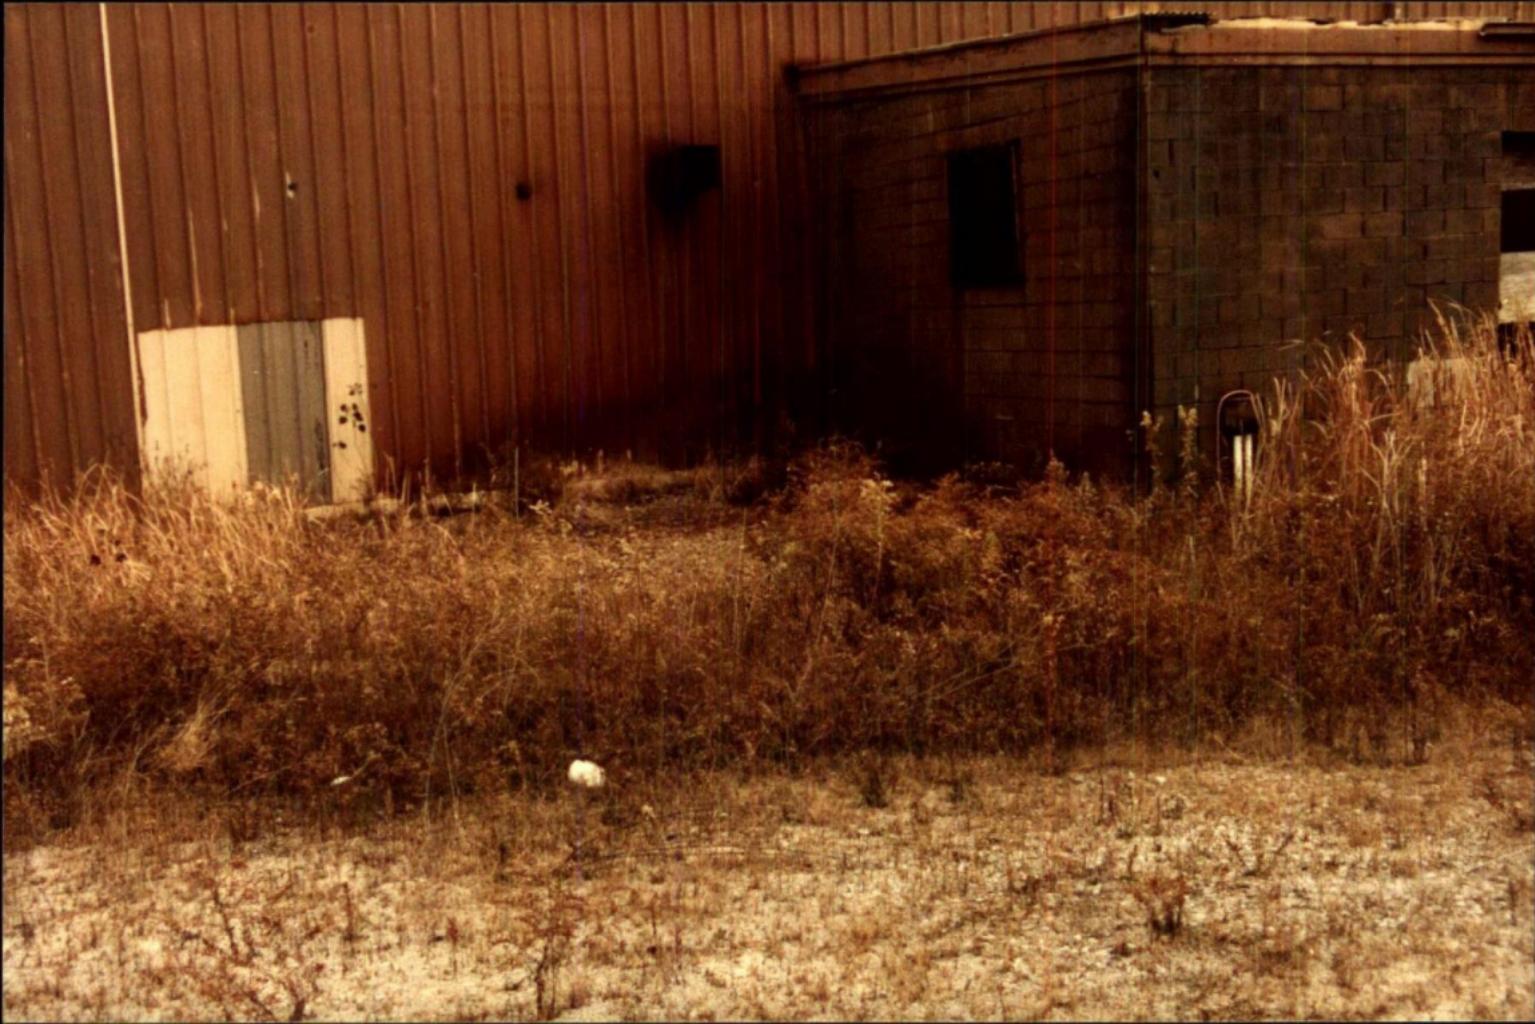
2-2

SITE NAME: TRI CONTAINER, INC. TDD#: T06-9311-011
PHOTO#: 202 PHOTOGRAPHER\WITNESS: NEELEY\LONG\BANIPAL
DATE: 11/09/93 TIME: 1052 DIRECTION: NE
SOUTH SIDE OF WAREHOUSE, SOUTH BAY.

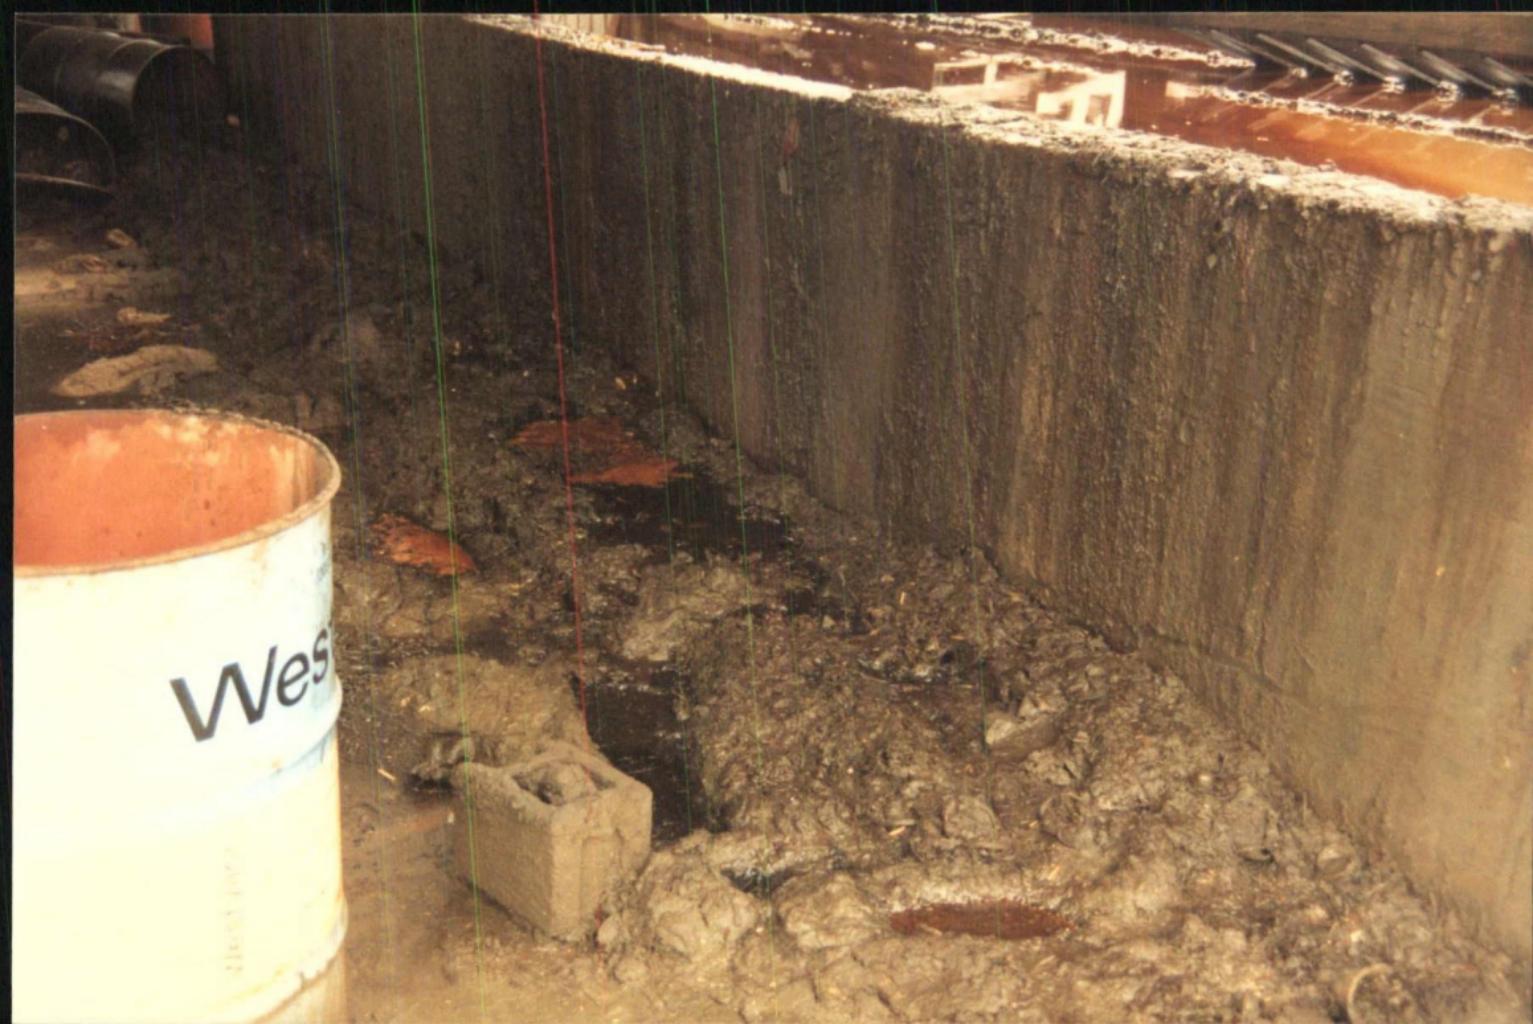
SITE NAME: TRI CONTAINER, INC. TOD#: T06-9311-011
PHOTO#: 204 PHOTOGRAPHER\WITNESS: NEELEY\LONG\BANIPAL
DATE: 11/09/93 TIME: 1055 DIRECTION: SW
DRUM WASH SHED. NOTE VATS AND SLUDGE (WASTE OIL?) ON FLOOR.

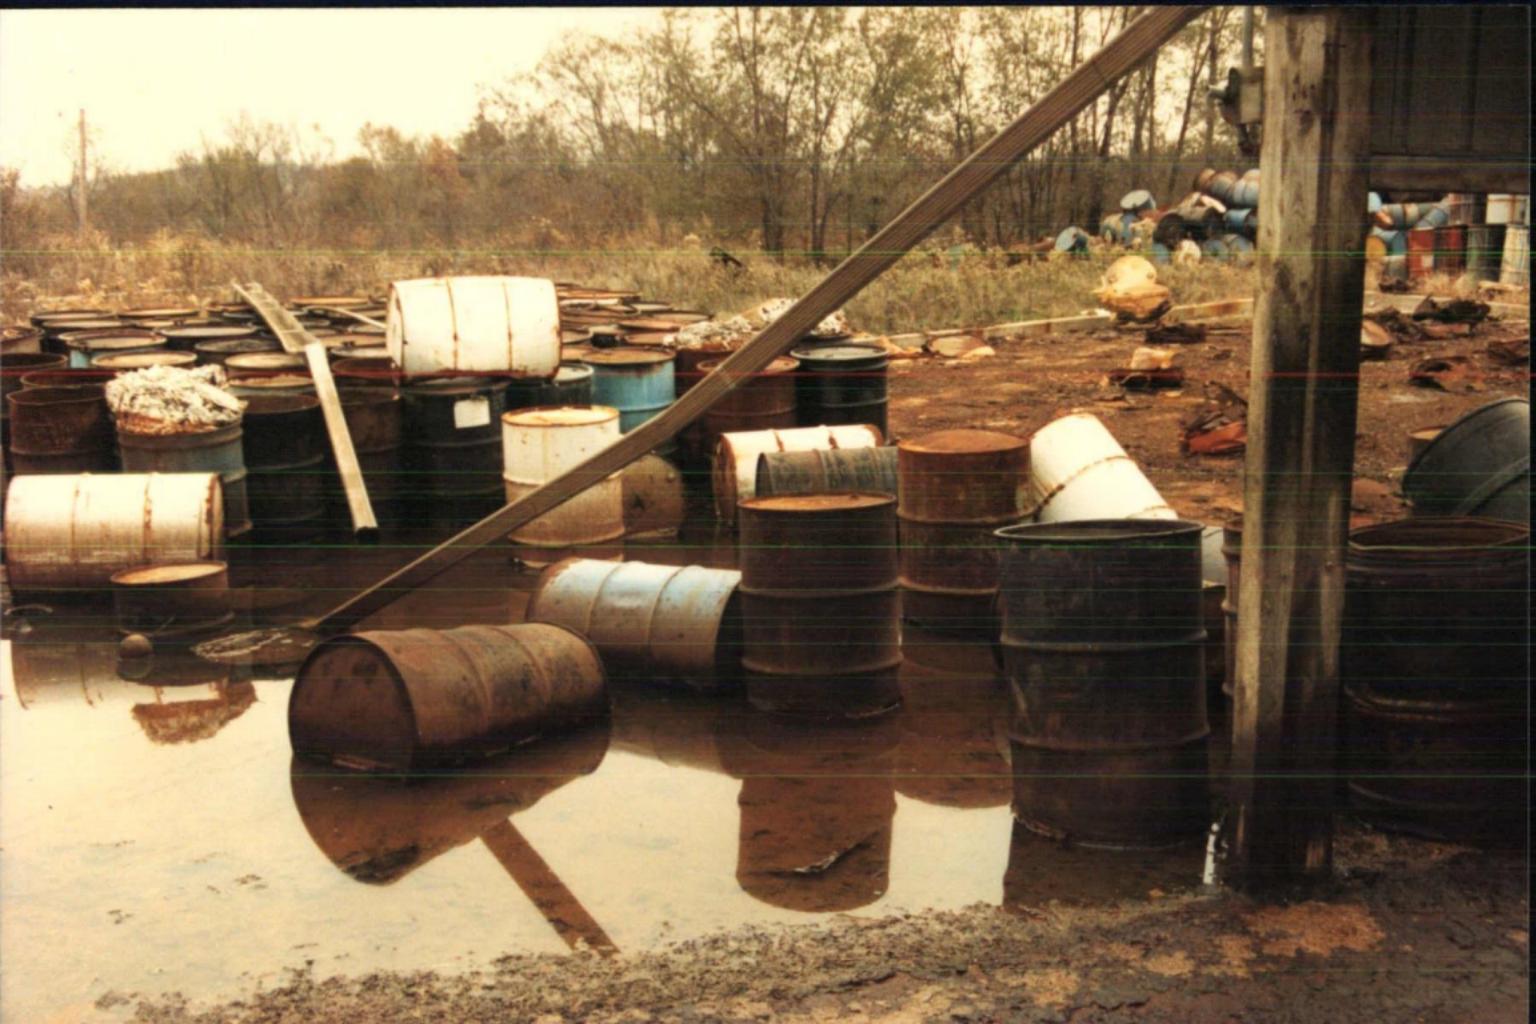
2-5

SITE NAME: TRI CONTAINER, INC. TDD#: T06-9311-011
PHOTO#: 205 PHOTOGRAPHER\WITNESS: NEELEY\LONG\BANIPAL
DATE: 11/09/93 TIME: 1056 DIRECTION: SE
VARIOUS DRUMS ON CEMENT SLAB AREA.

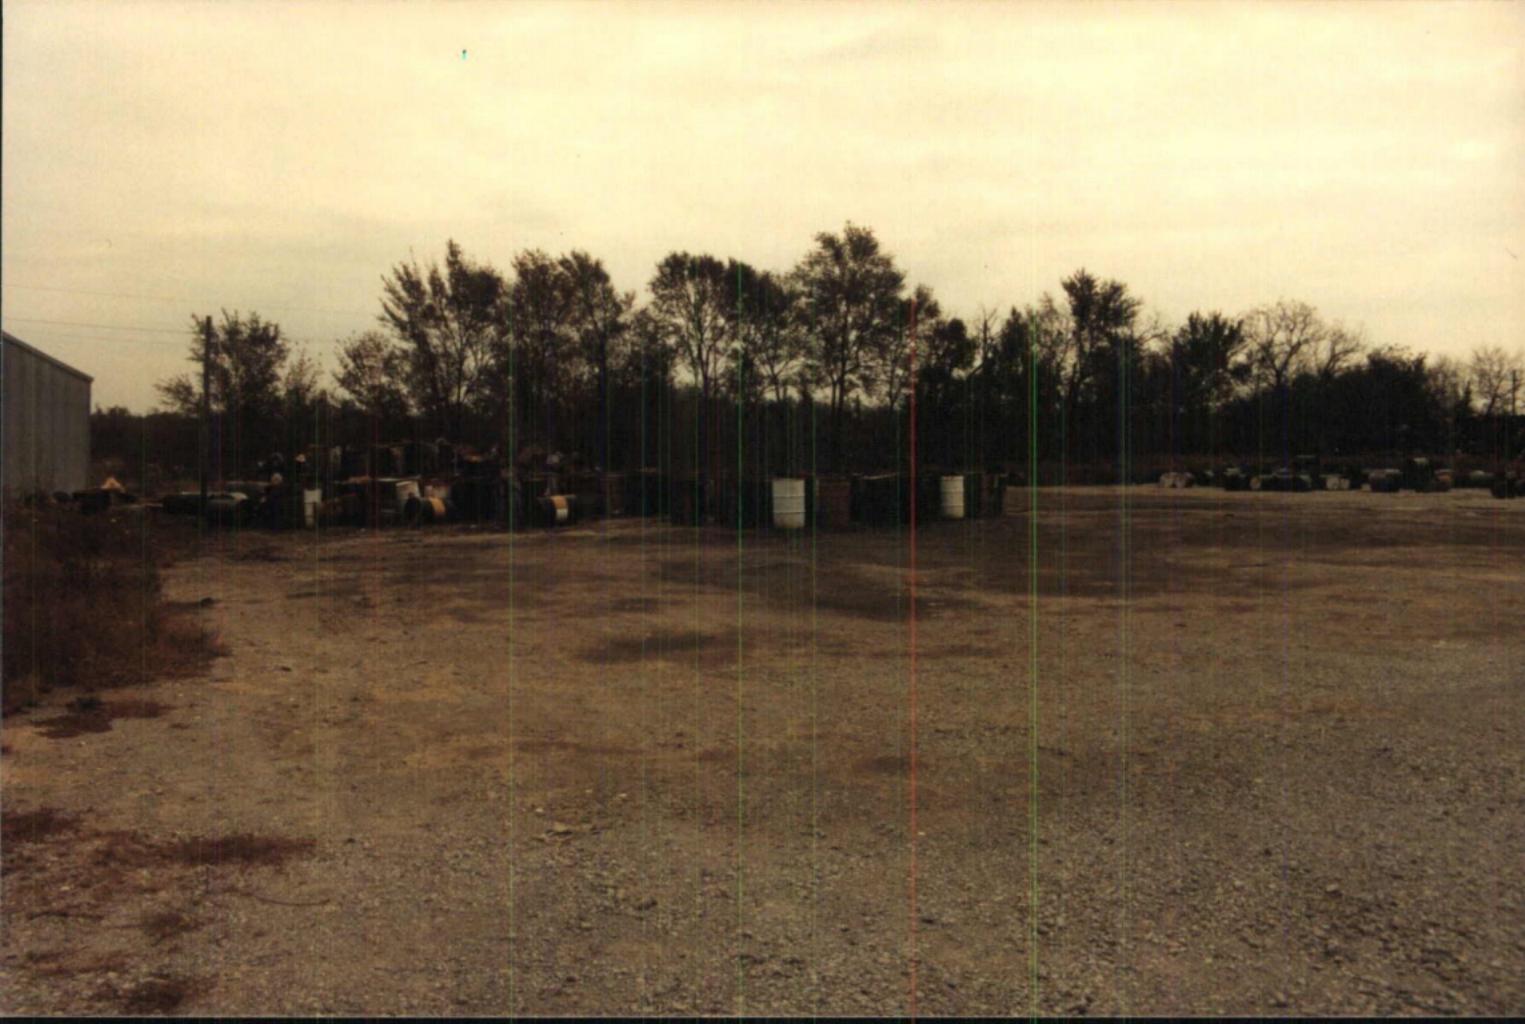
SITE NAME: TRI CONTAINER, INC. TOD# : T06-9311-011
PHOTO #: 207 PHOTOGRAPHER\WITNESS: NEELEY\LONG\BANIPAL
DATE: 11/09/93 TIME: 1110 DIRECTION: S
DRUMS STAGED IN GROUPS AND PILES. MOST DRUMS ARE EMPTY.

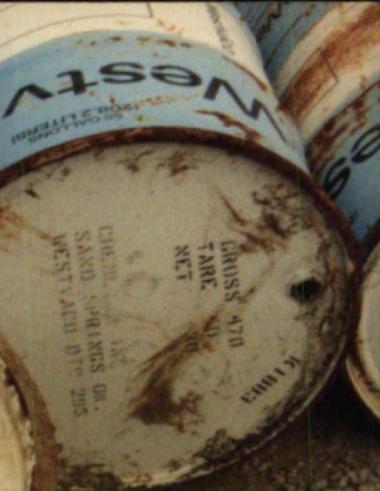
SITE NAME: TRI-CONTAINER, INC. TOD# T06-9311-011
PHOTO# 209 PHOTOGRAPHER\WITNESS: NEELEY\LONG\BANIPAL
DATE: 11/09/93 TIME: 1120 DIRECTION: DOWN
DRUM LABELED "DANGER CORROSIVE"
